Product Change Notification (PCN)

PCN #: 1A-2019 *DATE: 01/29/2019*

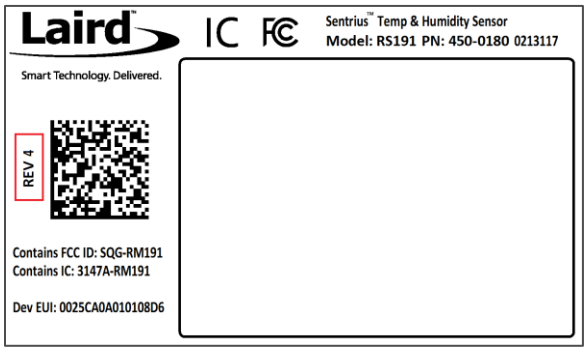
Previous Rev

- Labelling Changes – 450-0180
- A black dot near the barcode will indicator a firmware update to v4.5

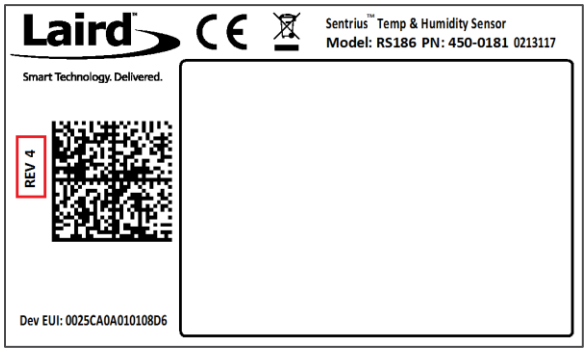
Previous Rev

- Labelling Changes – 450-0181

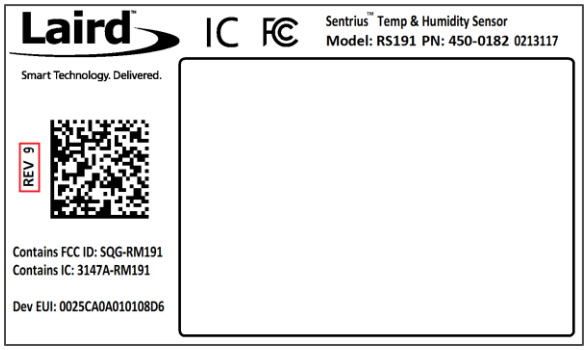
Previous Rev

- Labelling Changes – 450-0182

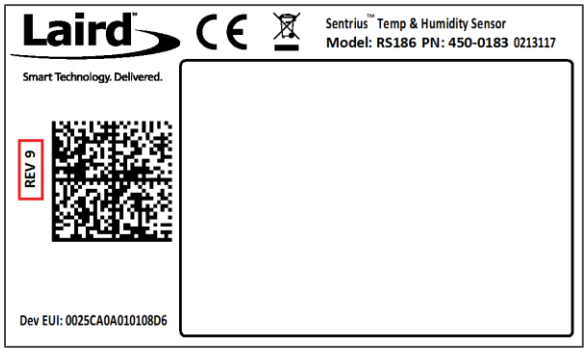
Previous Rev

- Labelling Changes – 450-0183
