PRODUCTION FIRMWARE LOADING PROCEDURE

Application Note

Production Firmware Loading Procedure – WB45NBT

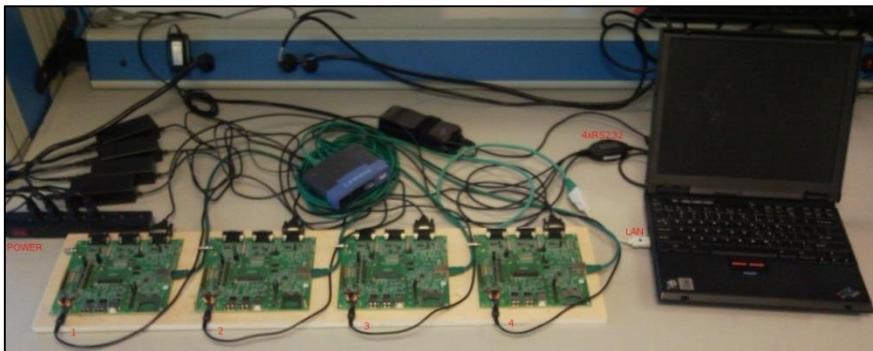
Figure 1: Procedure Setup

As shown in [Figure 1](#) and [Figure 2](#), the servers may reside on the same computer or independently. In this setup, these services are on the same computer and are running Linux. The four WB-# boards are plugged into a common power strip to allow them to be switched on or off at the same time.

Additionally, a *tk/tcl expect script* monitors the four WB modules and issues commands to the console of each.
