Notice of Non-Conformance (NoNC)

NoNC #: 1A-2026

Date: January 16th, 2026

2 Description of potential Non-Conformance

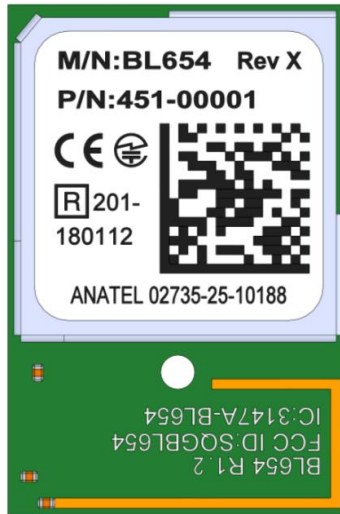
- **Module label** – inside the QR code. This is in the format YYMMDD and is the first 6 digits of the barcode readout.

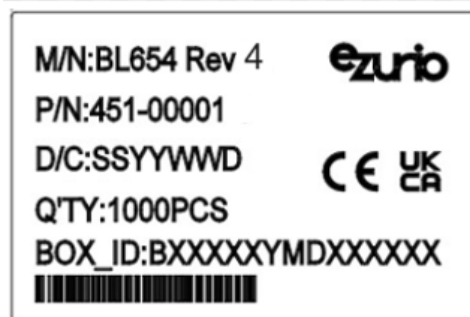
- 1) **Reel label** - The date code is shown in format SSYYWWD.

SS = Supplier code

YY = last two numbers of the year (ex: 18=2018, 19=2019)

WW = Week of the year

D = day of the week (ex: Sun=1, Mon=2, Tue=3, Wed=4, Thu=5, Fri=6, Sat=7)

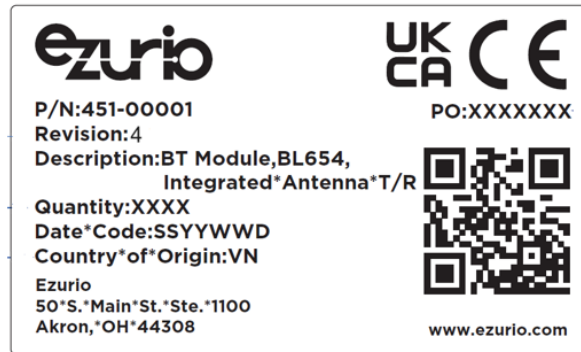
2) **Carton label** - The date code is shown in format SSYYWWD.

SS = Supplier code

YY = last two numbers of the year (ex: 18=2018, 19=2019)

WW = Week of the year

D = day of the week (ex: Sun=1, Mon=2, Tue=3, Wed=4, Thu=5, Fri=6, Sat=7)
